Mackworth TX Ceiling Lift Troubleshooting Guide

Scenario: Ceiling Lift does not raise and lower - No Lim Sw!

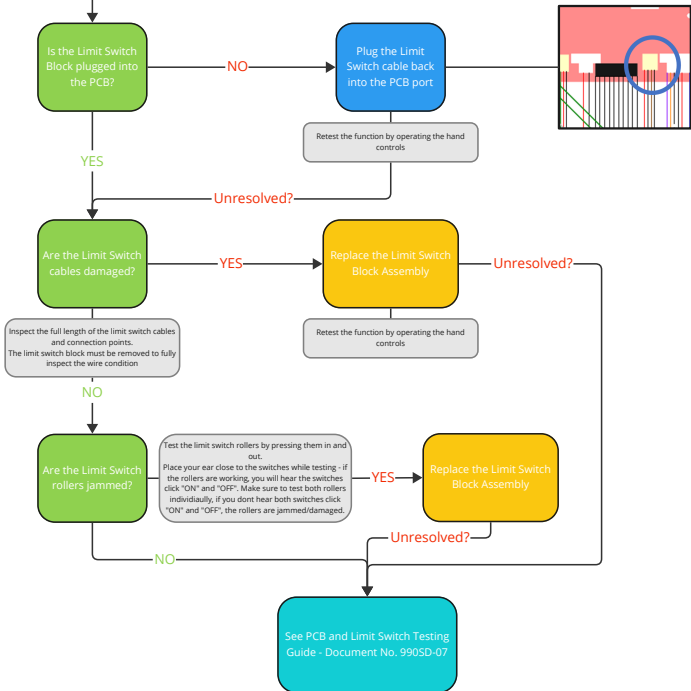
When operating the hand controls, the ceiling lift LCD indicates "No Lim Sw!" and an audible alarm will continuously beep for 3 seconds.
