# Mackworth TX Ceiling Lift Troubleshooting Guide

## Scenario: Ceiling Lift LCD is not functioning

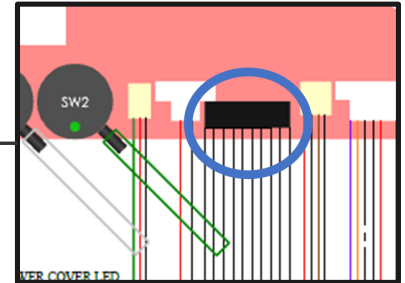
Is the LCD cable connected to the PCB?

Plug the LCD cable back into the PCB port
